Alcohol Tank Fire Detection

Santiago de Chile, Chile

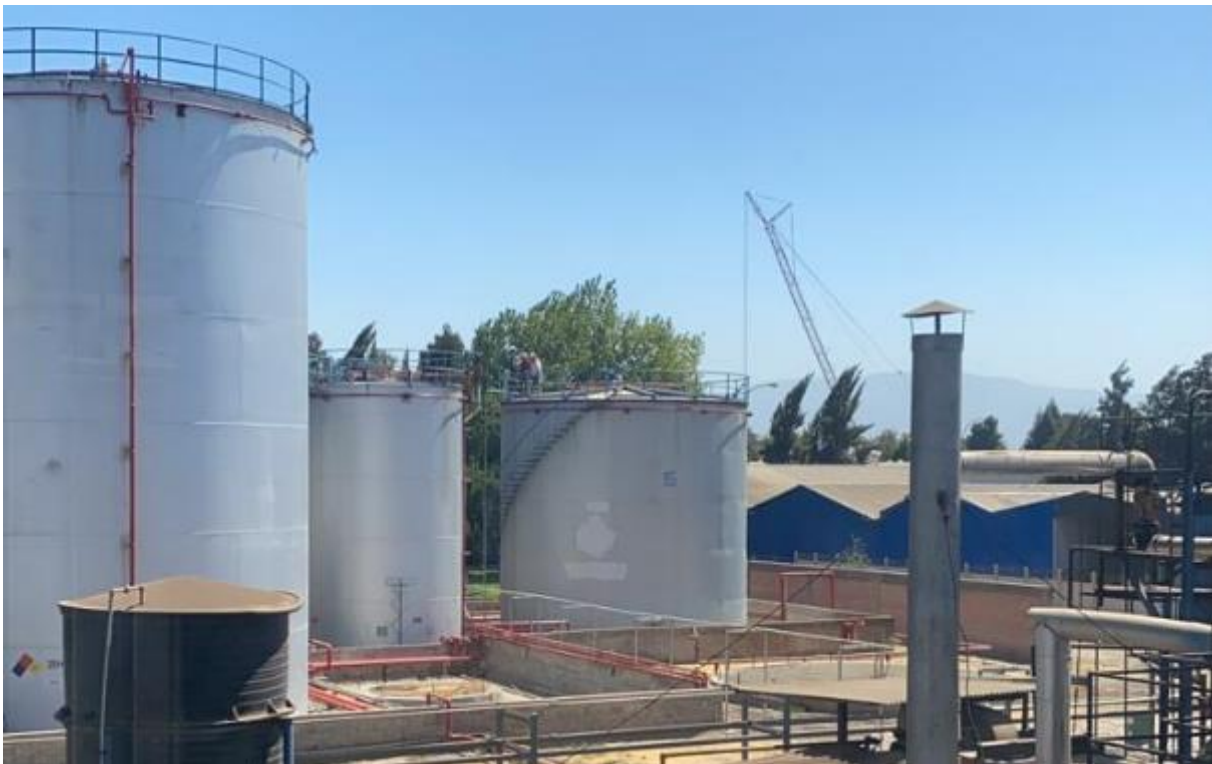
Alcohol tanks onsite

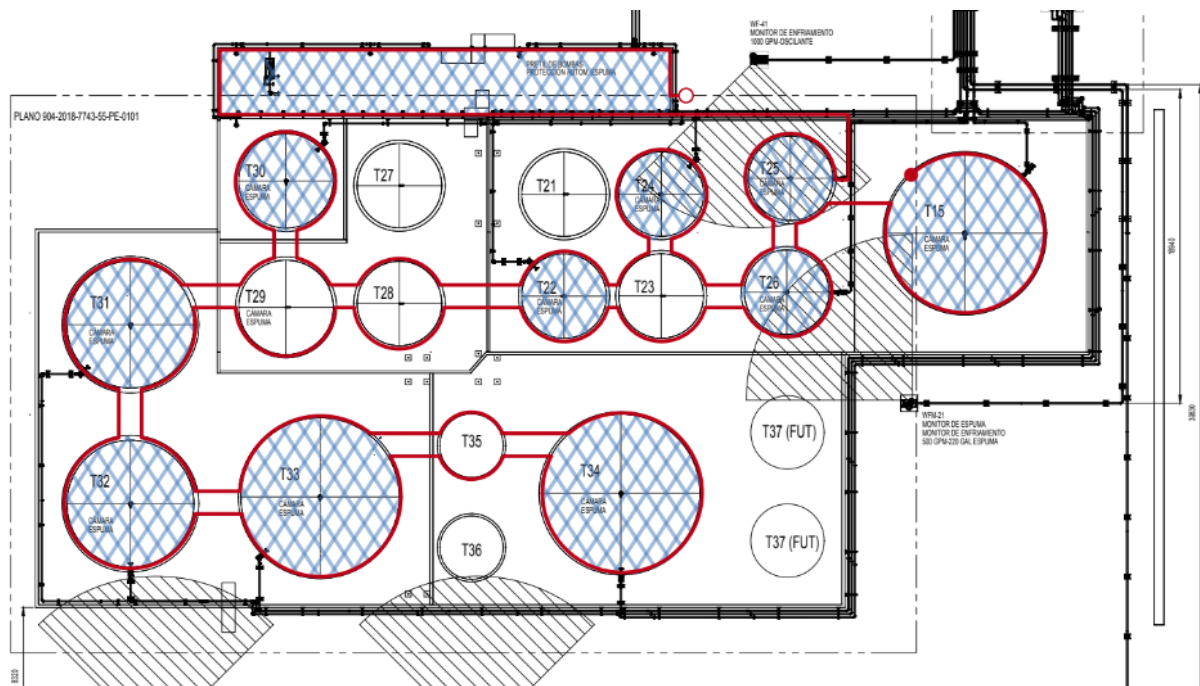
Tanks Distribution Drawing

The armored sensor cable was installed and distributed throughout all the different tanks as illustrated in the drawing above. Each individual red circle on the drawing represents one tank and therefore one single fire zone. Not all tanks are required to be monitored, as some tanks onsite store substances such as water, which is not flammable or potentially harmful. The sensor cable is installed in cable trays that run between tanks.
